Structural, morphological, compositional, and mechanical changes of palatal implants after use: a retrieval analysis

Schätzle, Marc ; Zinelis, Spiros ; Markic, Goran ; Eliades, George ; Eliades, Theodore

Schätzle, Marc; Zinelis, Spiros; Markic, Goran; Eliades, George; Eliades, Theodore (2017). Structural, morphological, compositional, and mechanical changes of palatal implants after use: a retrieval analysis. *European Journal of Orthodontics*, 39(6):579-585.

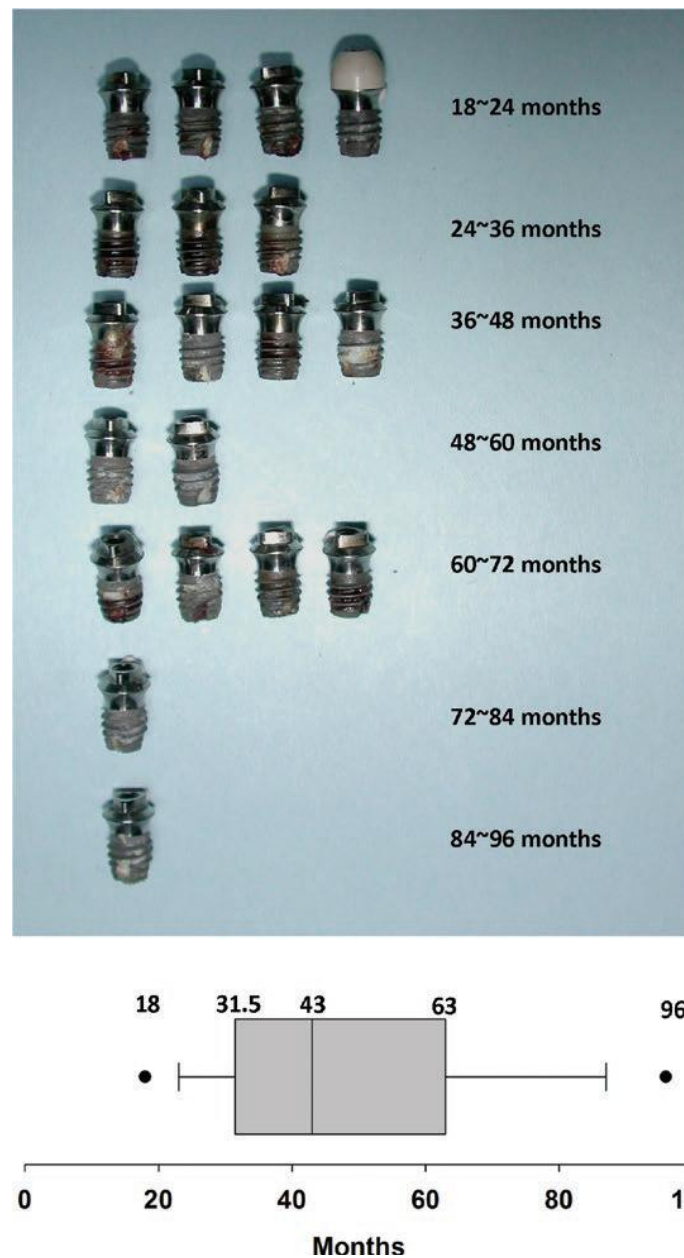
Fig 1. Photograph showing the retrieved implants classified in groups based on intraoral aging time. The side with the maximum integument coverage has been shown from the implant's surface. It is clear that the presence of white integuments increases over the aging time. The horizontal box plot indicates the median the 25 and 75% percentiles and the minimum and maximum intraoral time of the sample collected.

Fig 2 presents the surface of reference and representative retrieved implants. As it clearly shows also in Fig 1 and 2 the retrieved implants have lost their initial surface gloss while firmly attached white and yellow integuments are easily identified.

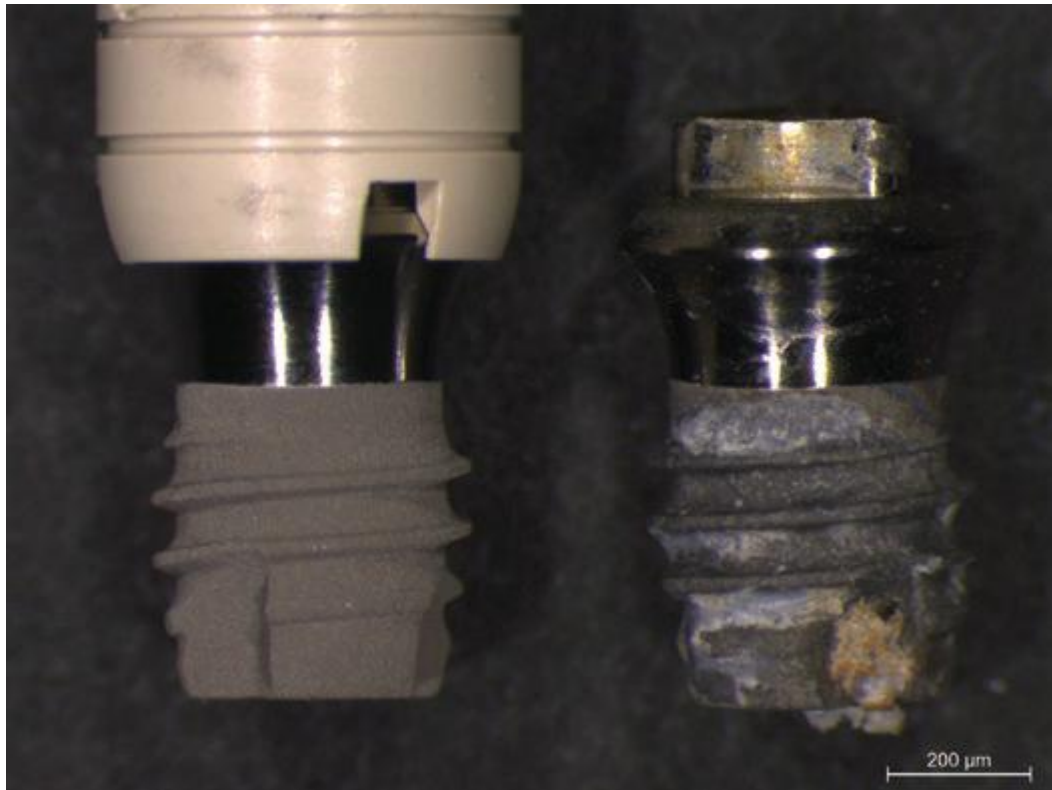
Fig 2. Representative optical images from the surface of CON (A) and RET groups (B). The retrieved implants have less gloss compared to control, while white and yellow bone like formations are easily identified on their surface.

As it was expected all retrieved implants demonstrated a loss of gloss due to the adsorption of biological fluids, and the development of retained oral integuments and bone like formations (Fig 2B, 4B and 5B). Although in this study the bone like formations did not quantified (i.e bone implant contact measurement) it is profound from Fig 1 that these formations are more likely to be observed on implants with increased intraoral time (Fig 1). Despite the intraoral aging BE image of retrieved samples (Fig 5B) demonstrate that part of the surface remained free of intraoral integuments and thus might explain why the roughness parameters of macroscopically intact retrieved implants remain unaffected by intraoral aging. (Table 1). The elemental composition of retrieved surface with bone like formation are dominated by the presence of Ca and F (Fig 6B and 7) and less amounts of C, O, Na, Mg, Al, S, Cl and K, all of them of biological origin. The presence of these elements has been also identified in retrieved orthodontic miniscrew implants (Eliades et al. 2009) and generally it is considered as a typical aging profile for implantable metallic materials (Eliades et al. 2000) involving in first place the adsorption of proteinaceous integuments with subsequent calcification in second place with the precipitation of F and Ca. The cross section analysis (Fig 10 and 11) revealed a distinct and well-formed interface denoting a rather well adhesion of bone like integuments to implant surface. This might not be desirable for orthodontic palatal implants from a clinical standpoint as their placements is considered temporarily and the removal of bone may trauma the bon increasing patient discomfort and healing time. No differences in mechanical properties tested were determined implying that neither insertion nor functional loading exerted enough high stresses to trigger a degradation mechanism.

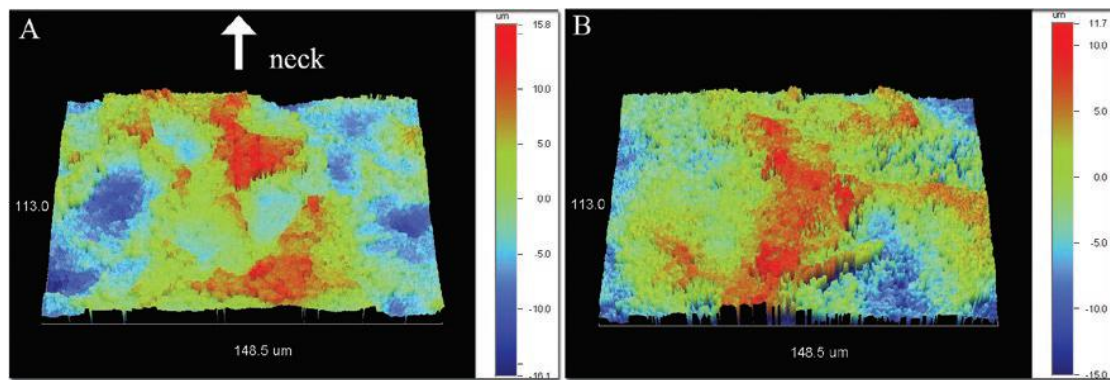
Fig 3. Representative 3D optical profilometric images from CON (A) and RET (B) implant surfaces. Both images have the same root-neck orientation indicated by the white arrow.

Representative 3D profilometric images are presented in Fig 3 while the roughness parameters are shown in Table 1. No statistical significant differences were identified for all parameters tested.

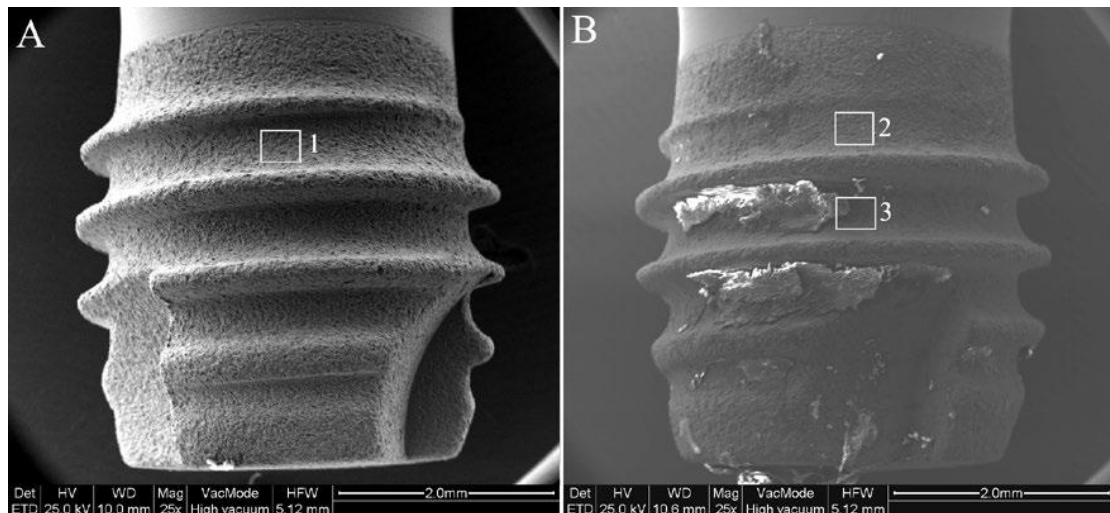
Fig 4. SE images from the surface of CON (A) and RET (B) groups. The presence of bone like integuments is easily identified within serrations. The regions 1 and 2 outlined by white rectangular indicate the locations where the higher magnification BE images were acquired. The region 3 presents the area of x-ray mapping where a part of bone like formation was also included. (Original magnification: 25X, bar 2mm).

Fig 4 demonstrates low magnification SE images from CON and RET groups where the attached integuments are identified as darker areas in BE due to lower mean atomic number compared to Ti. Higher magnification images (Fig 5) show that the reference surface is characterized by shallow grooves and micro pits, while the surface of retrieved implants illustrates intact regions along with regions covered by intra-oral integuments. The latter are easily distinguished due to their darker appearance in BE image (lower mean atomic number contrast) (Fig 5). EDX analysis revealed that reference implant surfaces consists mainly of Ti and traces of O and Al, while the surface of retrieved implants has been enriched mainly by C, O, Ca and P and traces of Na, Mg, K, S and Cl. BE image and X-ray distribution of C, N, O, P, Ca, Ti, Al, Mg, Na S and Si are presented in Fig 7. C, N and Ti illustrate random distributions. P and Ca depict similar distribution and in extent complementary to C distribution. All the rest elements present similar distributions.

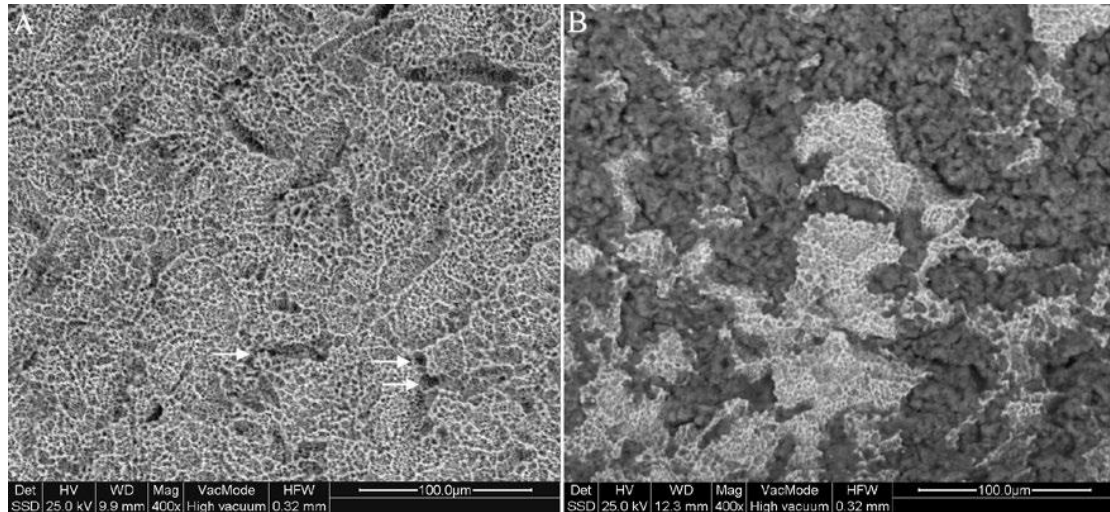
Fig 5. A) Representative BE image from the surface of control group with shallow grooves and pits and a random distribution of tiny regions of low atomic contrast in the valleys (a few pointed by the white arrows). B) BE from the surface of retrieve implants where the metallic substrate is covered by a randomly distributed lower mean atomic number phase (original magnification 400X, bar 100µm).

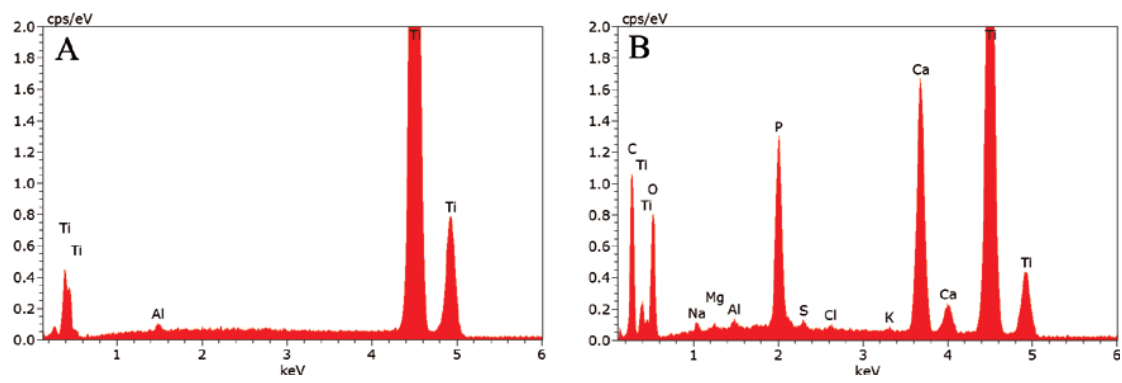
Fig 6. Representative EDX spectra from the surface of CON(A) and RET(B) implants.

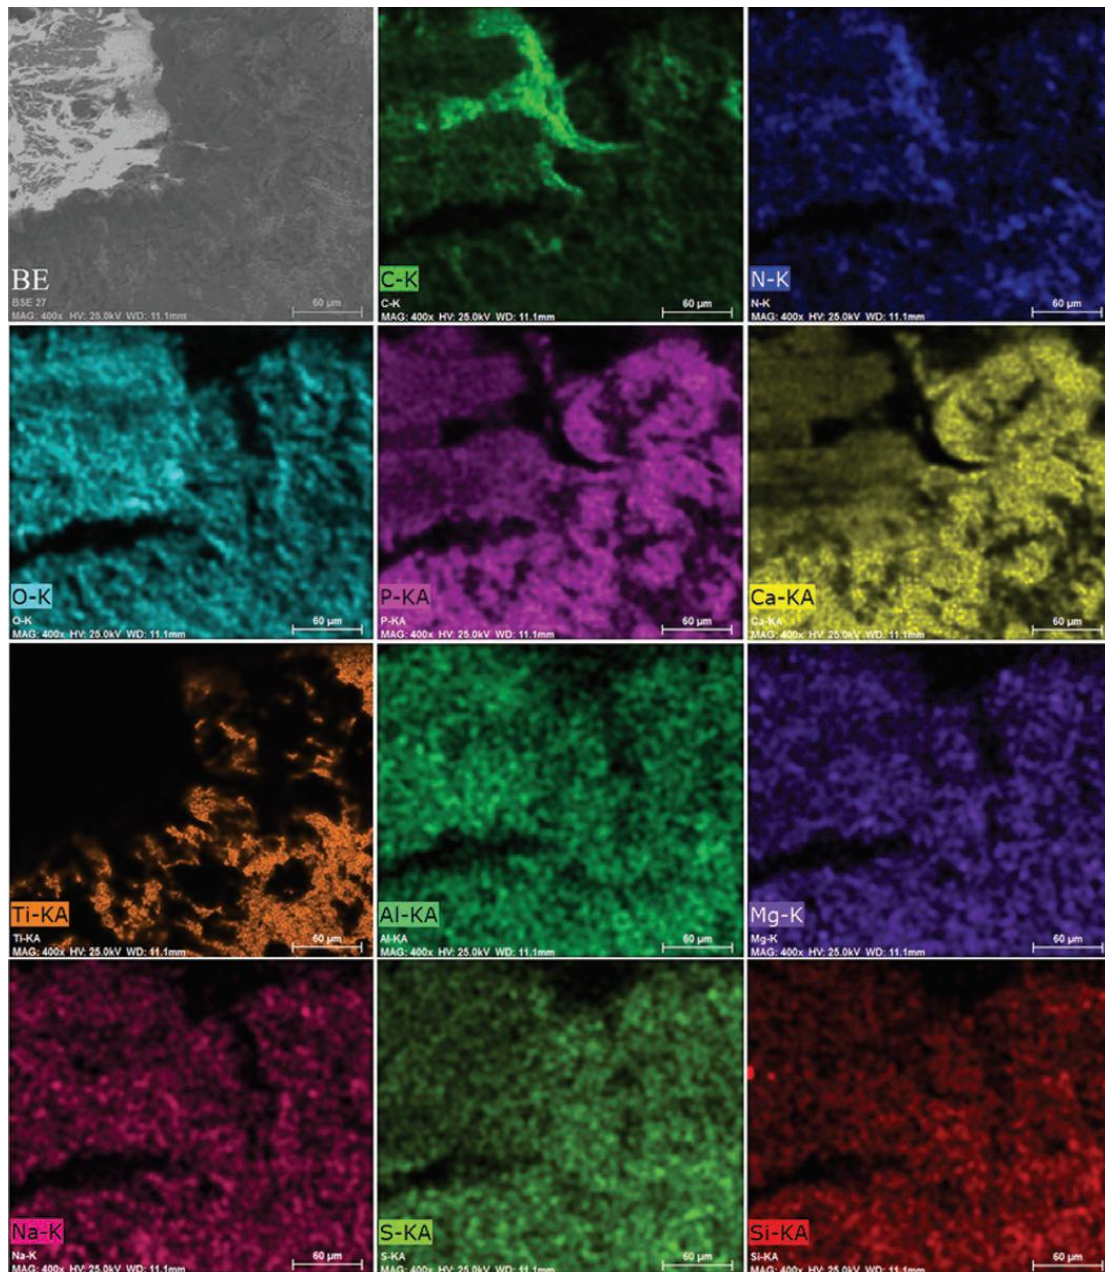
Fig 7. BE image and X-ray distribution of C, N, O, P, Ca, Ti, Al, Mg, Na S and Si. C, N and Ti illustrate a random distribution while similar distribution depict O, Al, Mg, Na, S and Si. P and Ca illustrate also similar distribution and in extent complementary to C distribution (bar 60µm).

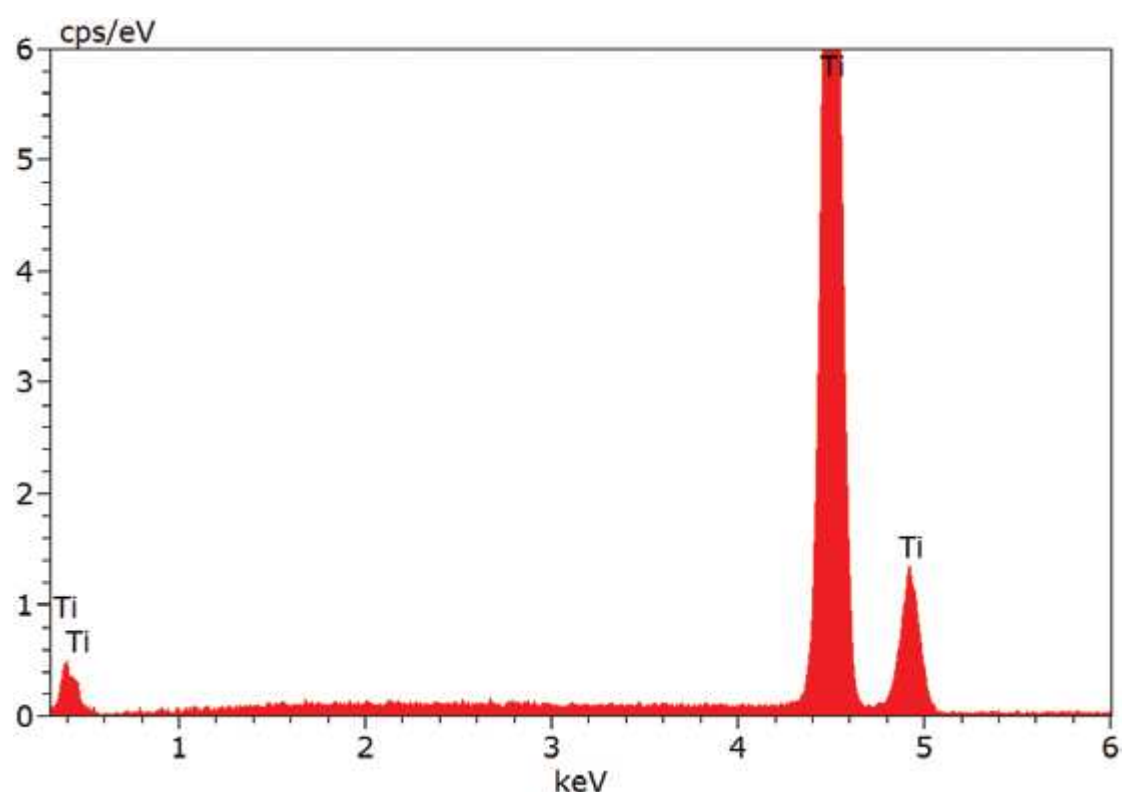
Fig 8. EDX spectrum from the cross section of implants tested.

An EDX spectrum from the cross-section of implant is presented in Fig 9 where only Ti was identified. High magnification interfacial analysis revealed a well formed and defined interface between implant and bone (Fig 10). Line scan analysis (Fig 11) demonstrates that Ti has a progressively reduction from metal to bone while O, Ca and P showed the inverse behaviour. Interestingly O has reached the maximum value at implant-bone interface while Ca and P further in bone structure.

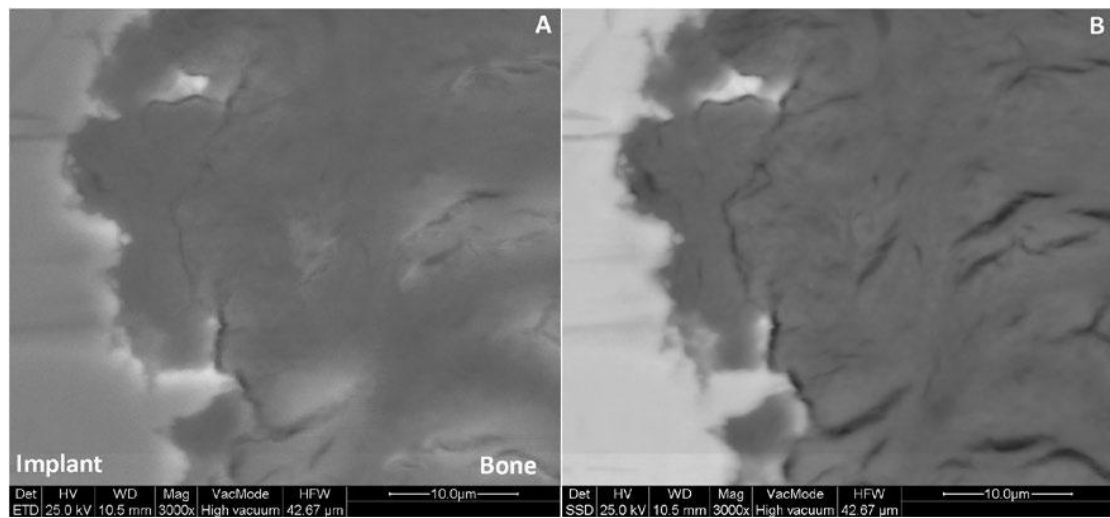
Fig 9. Representative SE (left) and BE (right) images from the implant-bone interface of retrieved palatal implants.

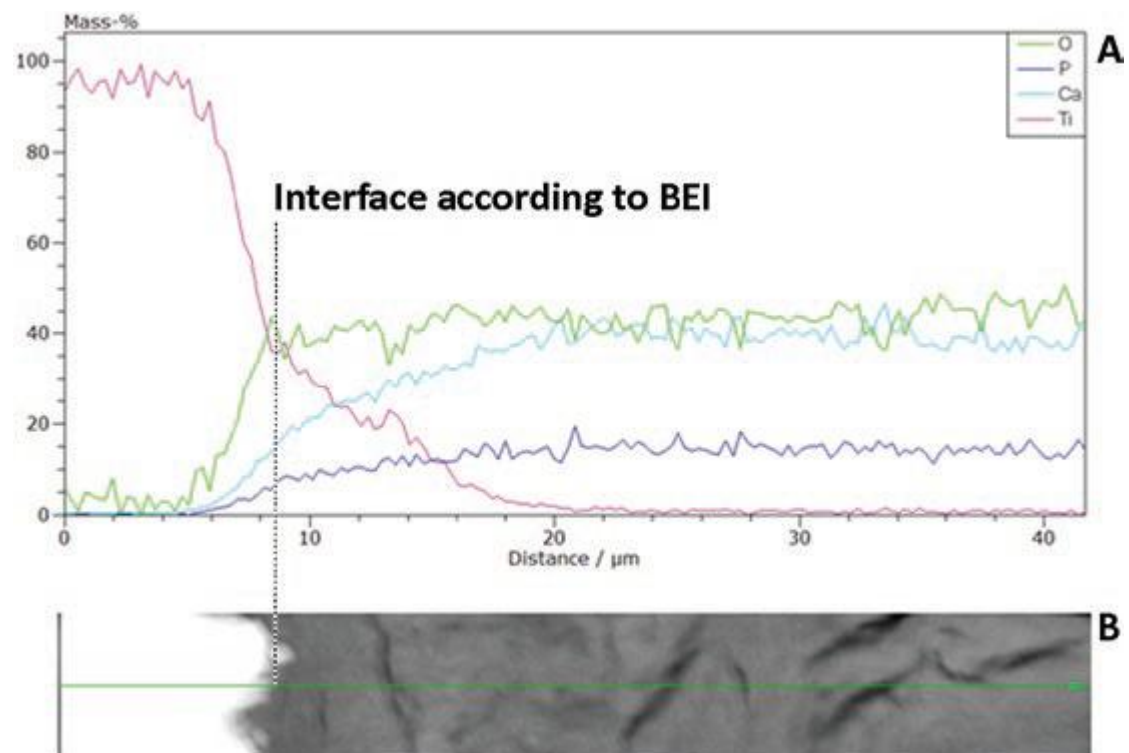
Fig 10. Line scan EDX analysis for Ti, O, P and Ca of the implant bone interface. The bottom shows part of the BE image of figure where the line scan was recorded.

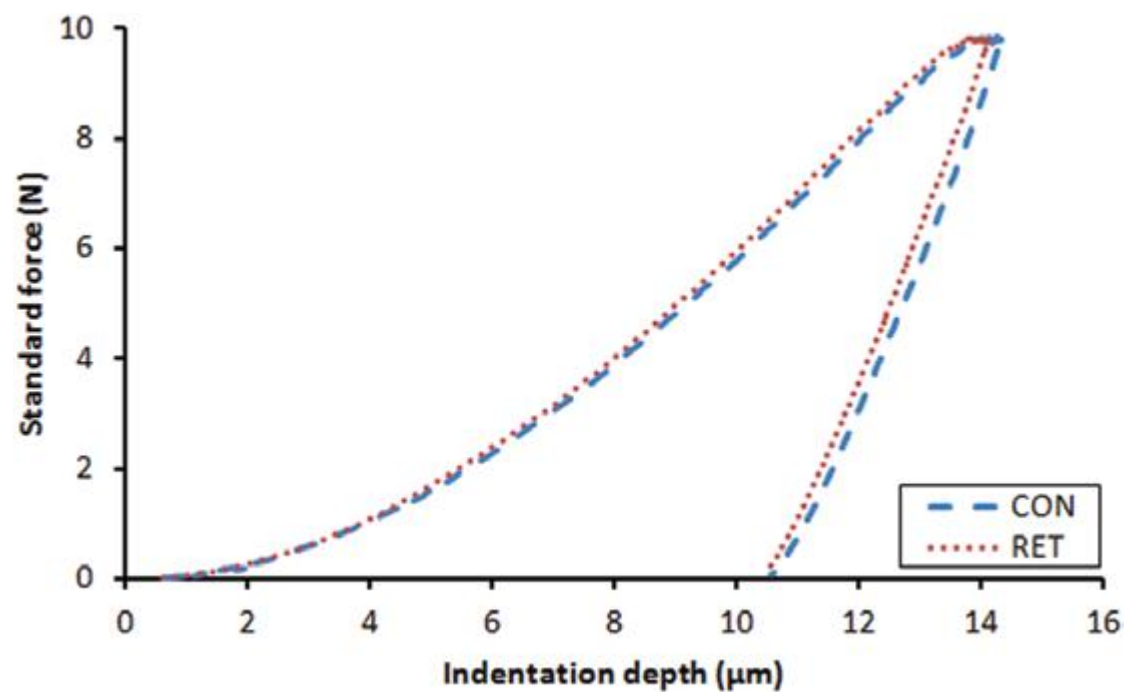
Fig 11. Representative load indentation depth curves for both groups tested.

Two representative force indentation depth curves from both groups are appeared in Fig 8. The results of mechanical properties tested are presented in Table 2 with no significant difference between the two groups.
